## 100kW WTGS Operation Report in Korea

From January, 2014 to July, 2014

**Abstract:** One FD21-100kW wind turbine from Shanghai Ghrepower was installed and running in Jeju Island, Korea on November 28<sup>th</sup> 2013. Since the Operation, the wind availability had reached over 97.65% without the consideration of regular maintenance. Based on the operation data analysis from January 2014 to July 2014 through the SCADA system (the remote monitoring system for WTGS), the operation state of the 100kW wind turbine was briefly introduced as following:

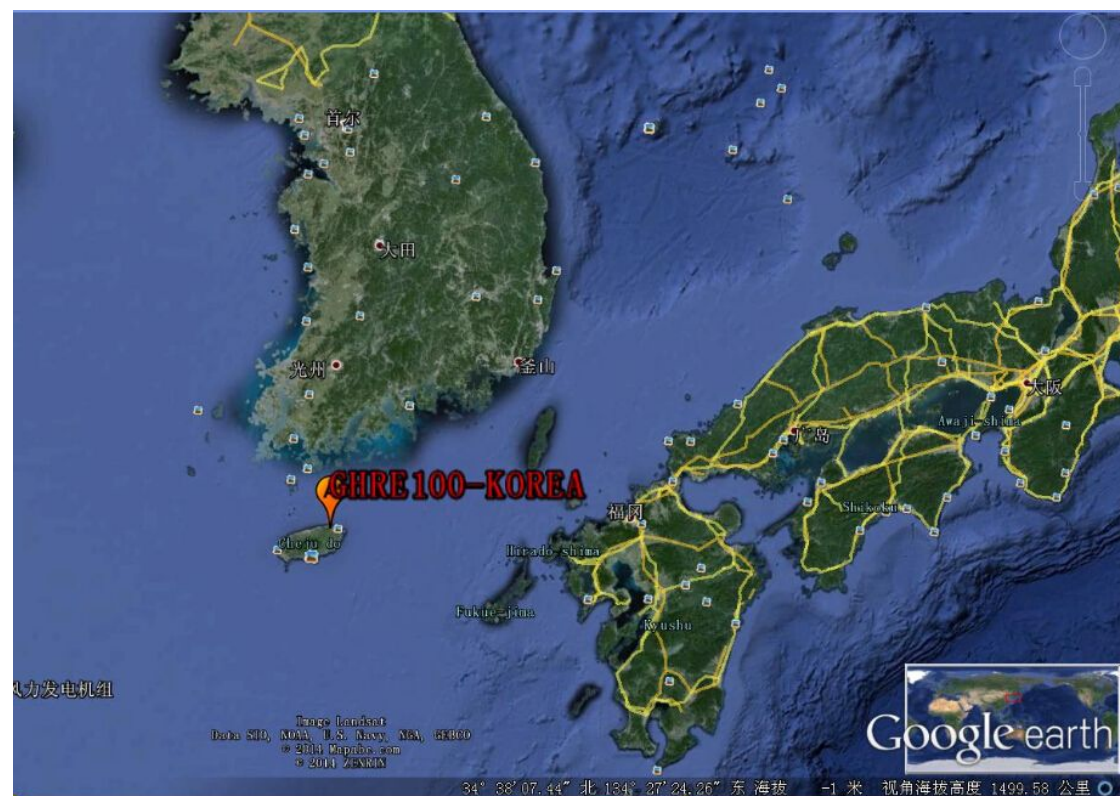
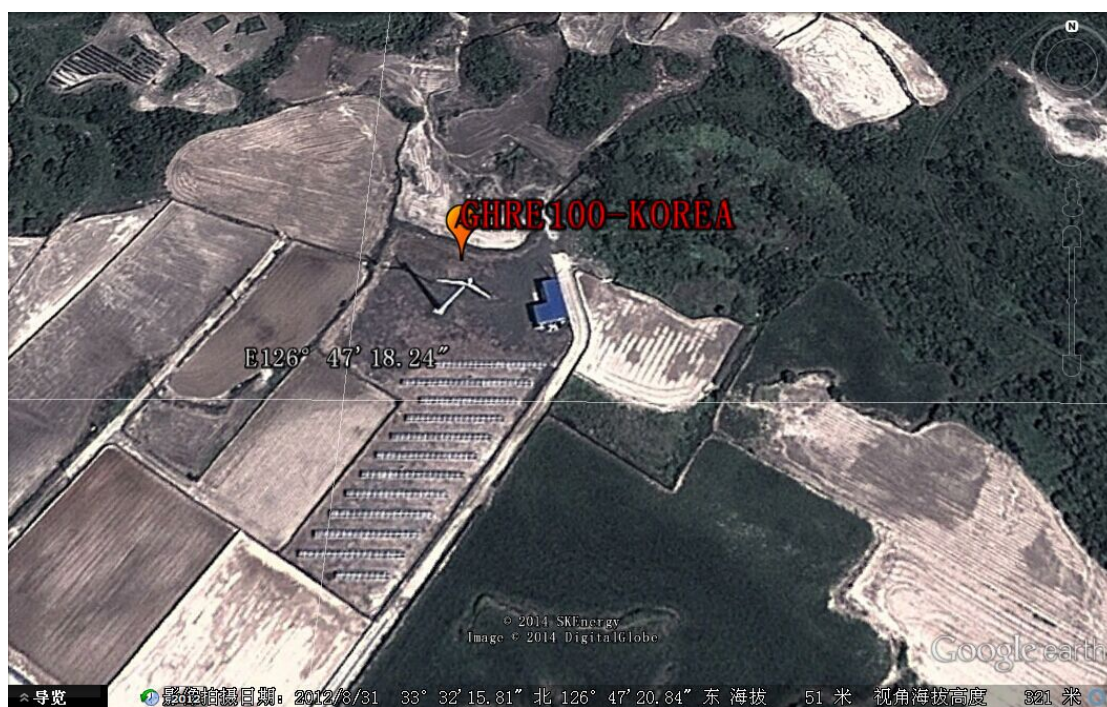
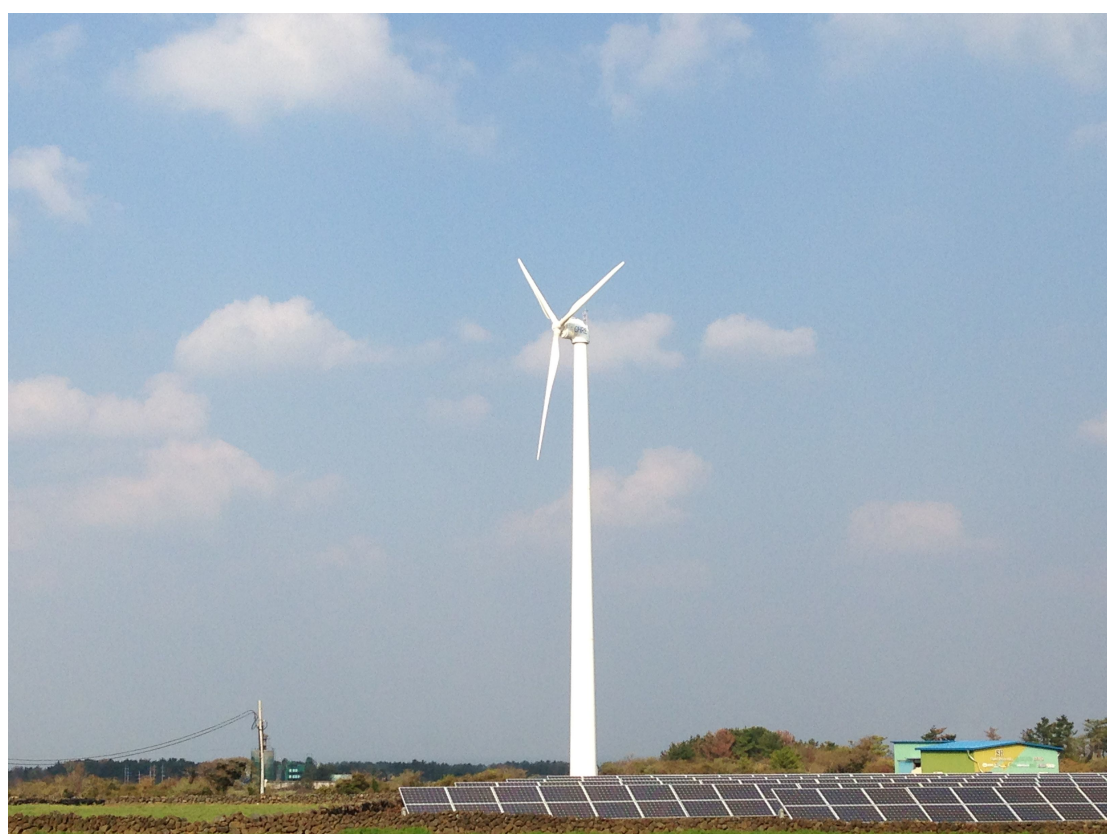
Figure 1

The wind turbine was located in the north-west of Jeju Island near the sea ( latitude: 33°32'15.81, Longitude: 126°47'20.84). From figure 1- figure 3, the annual average wind speed was about 6-7 m/s, it belonged to oceanic climate.

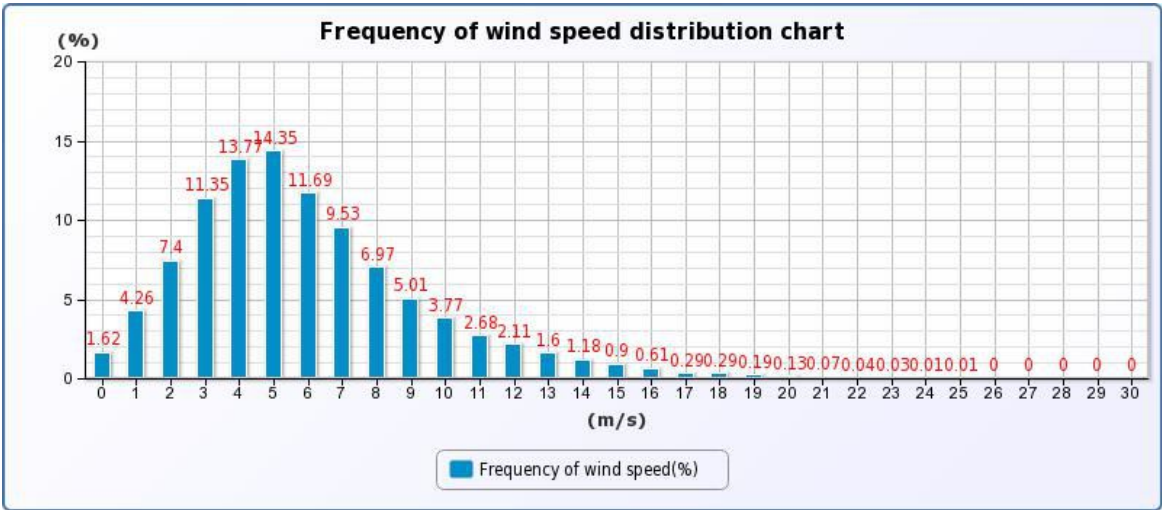
Figure 4

- The average wind speed and maximum wind speed of the first half year of 2014 is shown as Figure 4. The wind speed area between 4m/s and 6m/s was frequency, covering 39.81% of the whole measured wind speed data.

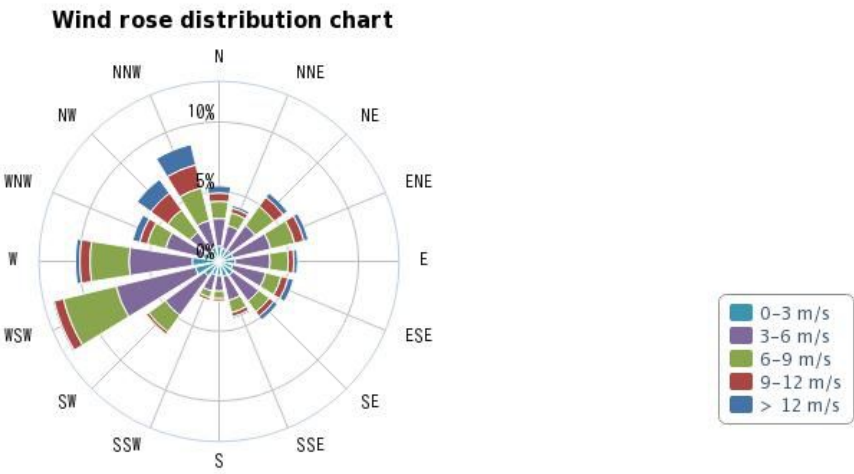
Figure 5

- From the wind rose of the first half year shown as Figure 5, the wind direction of southwest, west and northwest were much common, which covered 12.30%, 10.31% and 6.39%.

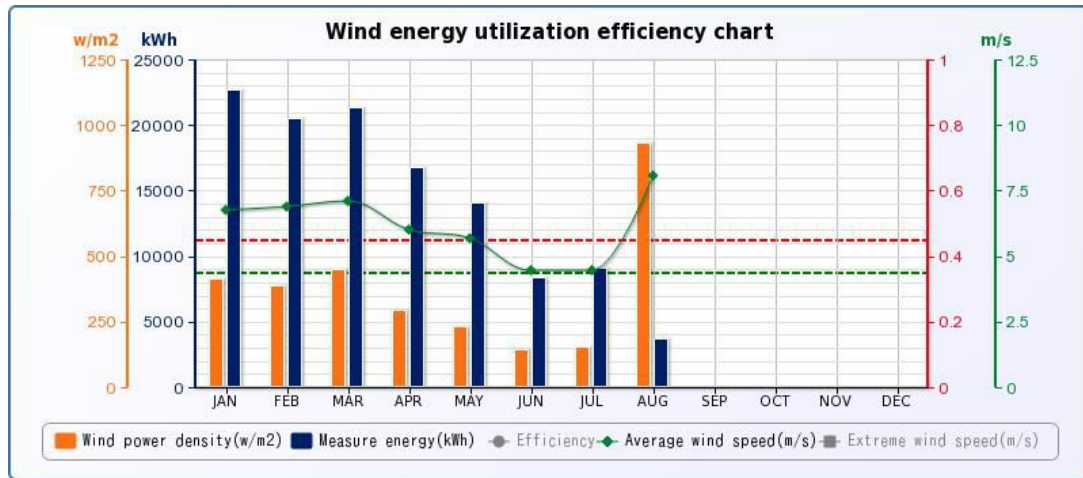
Figure 8

d reached 33.21m/s. Since the operation of December 2014 , the total generation of the WTGS was 116467.5kWh. And the generation from 2014 January to 2014 July had reached 112788.2kWh. The generation of each month is shown as Figure 8.

- The actual generation on the average wind speed from Jan to Jul was close to the theoretical generation.

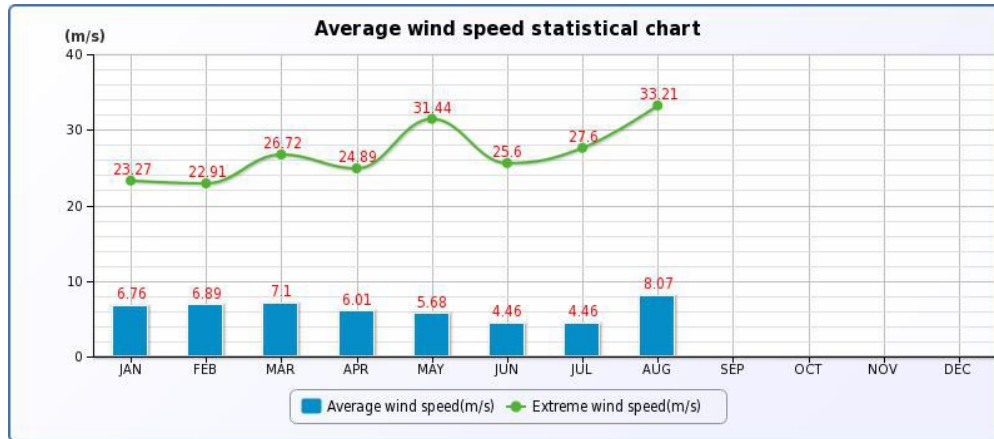
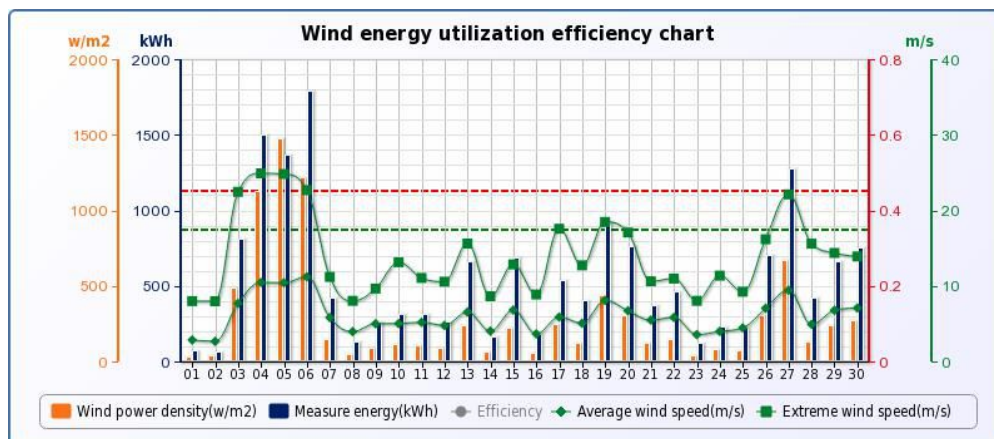
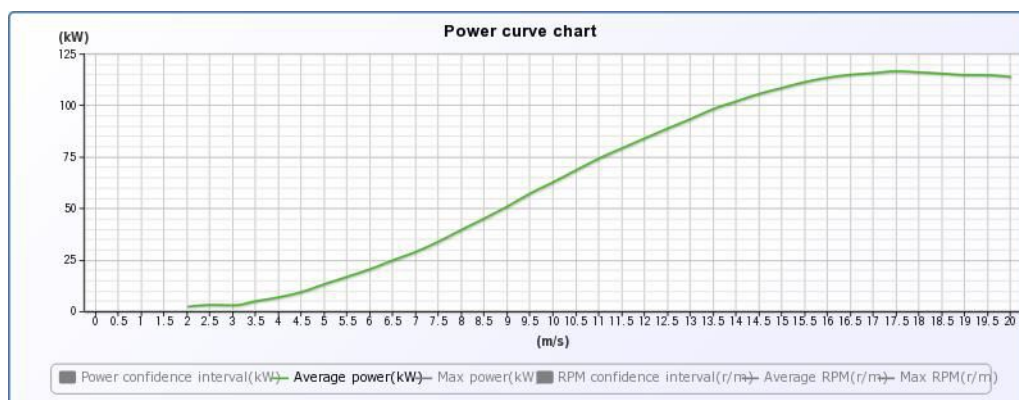
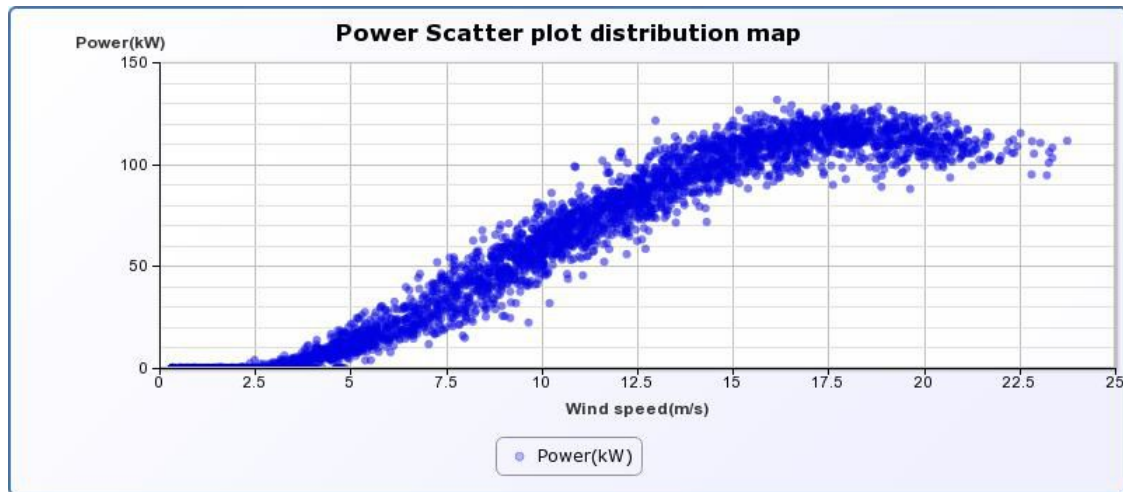
Figure 9

- The operating power curve and power scatter of WTGS on Apr 6<sup>th</sup>, 2014 for 48 hours in strong wind is shown as following Figures:

The average wind speed of Apr 6<sup>th</sup>, 2014(0:00-23:00) was 11.20m/s, maximum wind speed was 22.68m/s.

From the power curve and power scatter, it was clear that the generation output of the WTGS was smooth under different wind speed. Especially, the output was kept at rated output value with obvious fluctuation, which was close to the designing effect of WTGS theory.

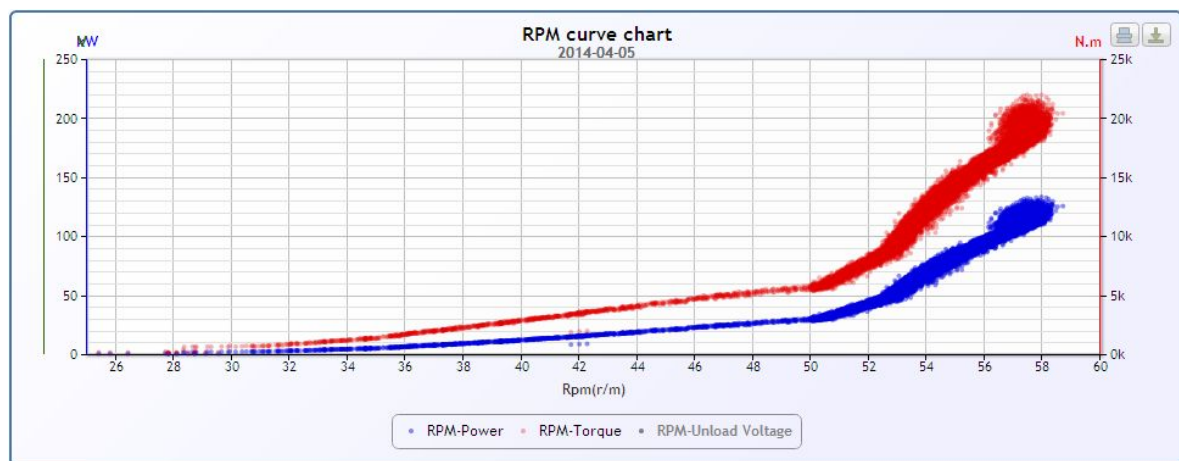
- Figure 13 has shown the generator rotating speed, torque, voltage and power scatter. It was clear that the inverter had always been in maximum power tracking state during the operation. When the output reached rated output, the rotating speed of generator was kept at 58RPM, the DC voltage of the system was kept at DC650V. Voltage and rotating speed had no obvious scatter distribution. The WTGS had been in operation under the ideal environment of constant torque, rotating speed and voltage.

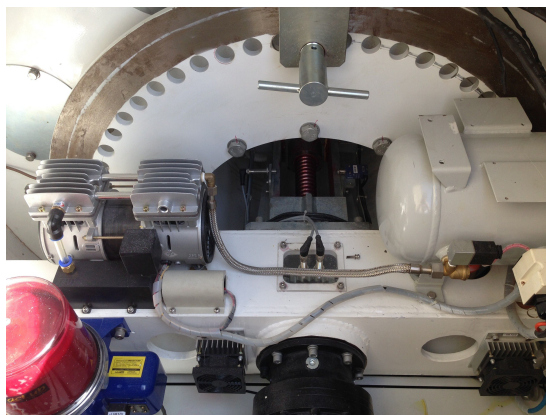
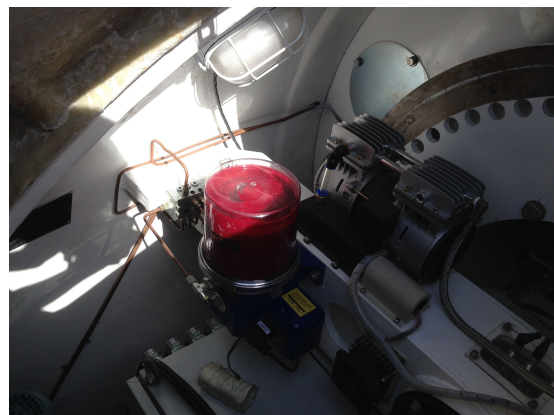
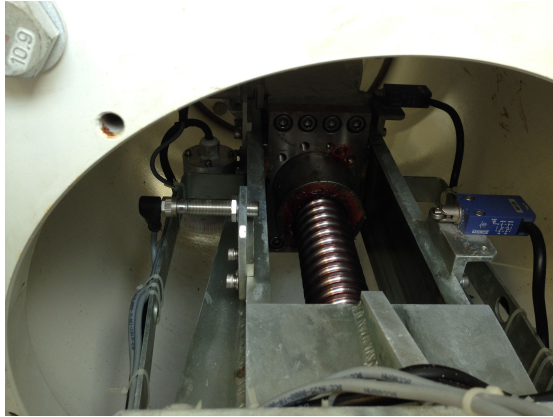
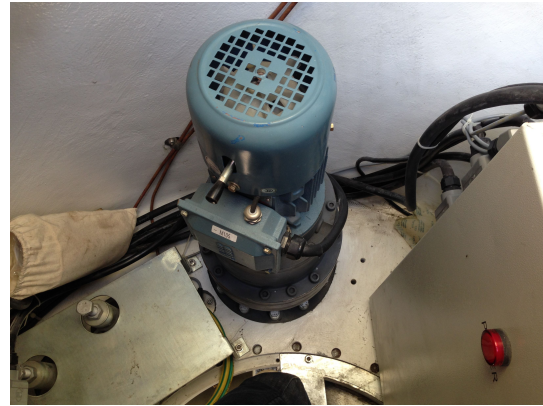
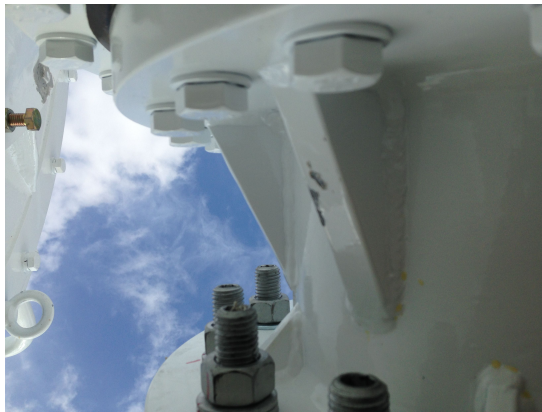
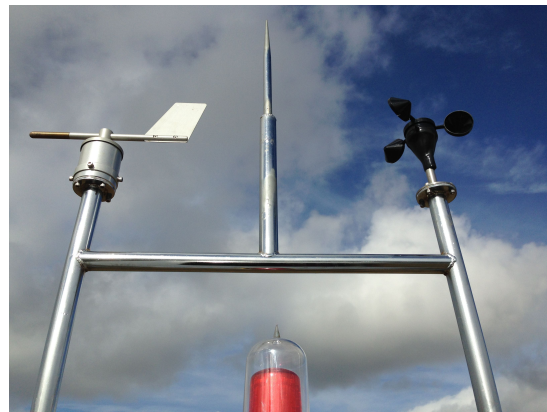
Figure 14

- The WTGS was installed on the Island surrounding by Sea, whose components may be contacted with the salty water due to the prevailing land and sea breeze. Therefore, it was highly required for the anti-corrosion. During the design, anti-salt-mist material had been added. Such as: 1. The bolts, nuts and other fasteners were disposed with Dacromet anti-rust and galvanization technology. 2. The surface of the blades was covered with photocatalytic coating, which can use the sunshine, rain and air as basic reaction medium to decompose the pollutant, achieving the goal of anti-fog and self-cleaning. 3. The area where the electrical components centralized was sealed to repel moisture with cooling protection, so that the corrosion rate can be slowed down. After 7 months operation, it was clear that the anti-corrosion of the WTGS worked well from the Figure 14-19.
